ROCKETDYNE

R-5316

FINAL REPORT, DEVELOPMENT OF DOWNRATED
ATLAS YLR101-NA-15 VERNIER ENGINE

Contract AF04(695)-306

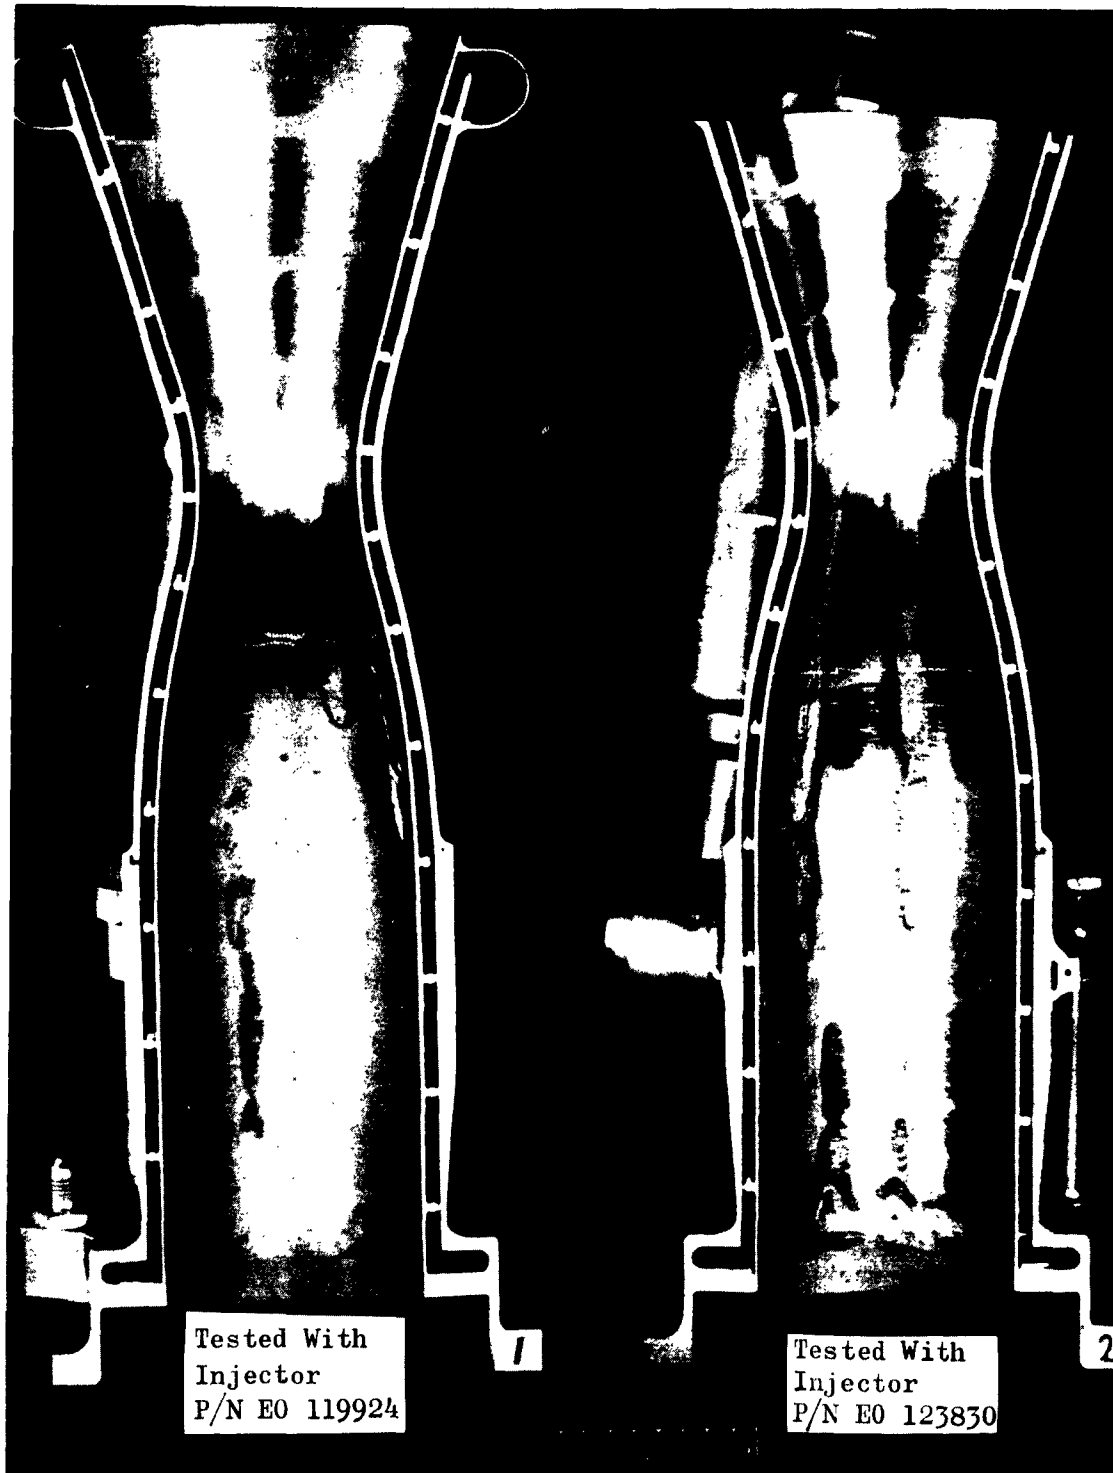
1BS35-9/4/63-C1E

Ten duration tests were completed on the P/N EO 123830 injector. The first test was terminated early because of the erratic parameters, and the 2-inch facility line was replaced by a 1-inch line to eliminate any problem with gaseous oxygen. The testing was continued with only a slight shift in the performance parameters. Minor thrust chamber erosion was evident after 700 seconds, but testing was continued after concluding that the erosion had been caused by a plugged orifice. No further erosion occurred during subsequent tests. The second P/N EO 123830 unit was not tested because of heavy streaking noted when the first chamber was sectioned and inspected following testing (Fig. 26). The operating regime of the P/N EO 123830 injector until the time of erosion is shown in Fig. 28.

Figure 26. Sectioned Vernier Engine Showing Thrust Chamber Erosion Resulting After Tests With Injectors P/N E0 119924 and P/N E0 123830

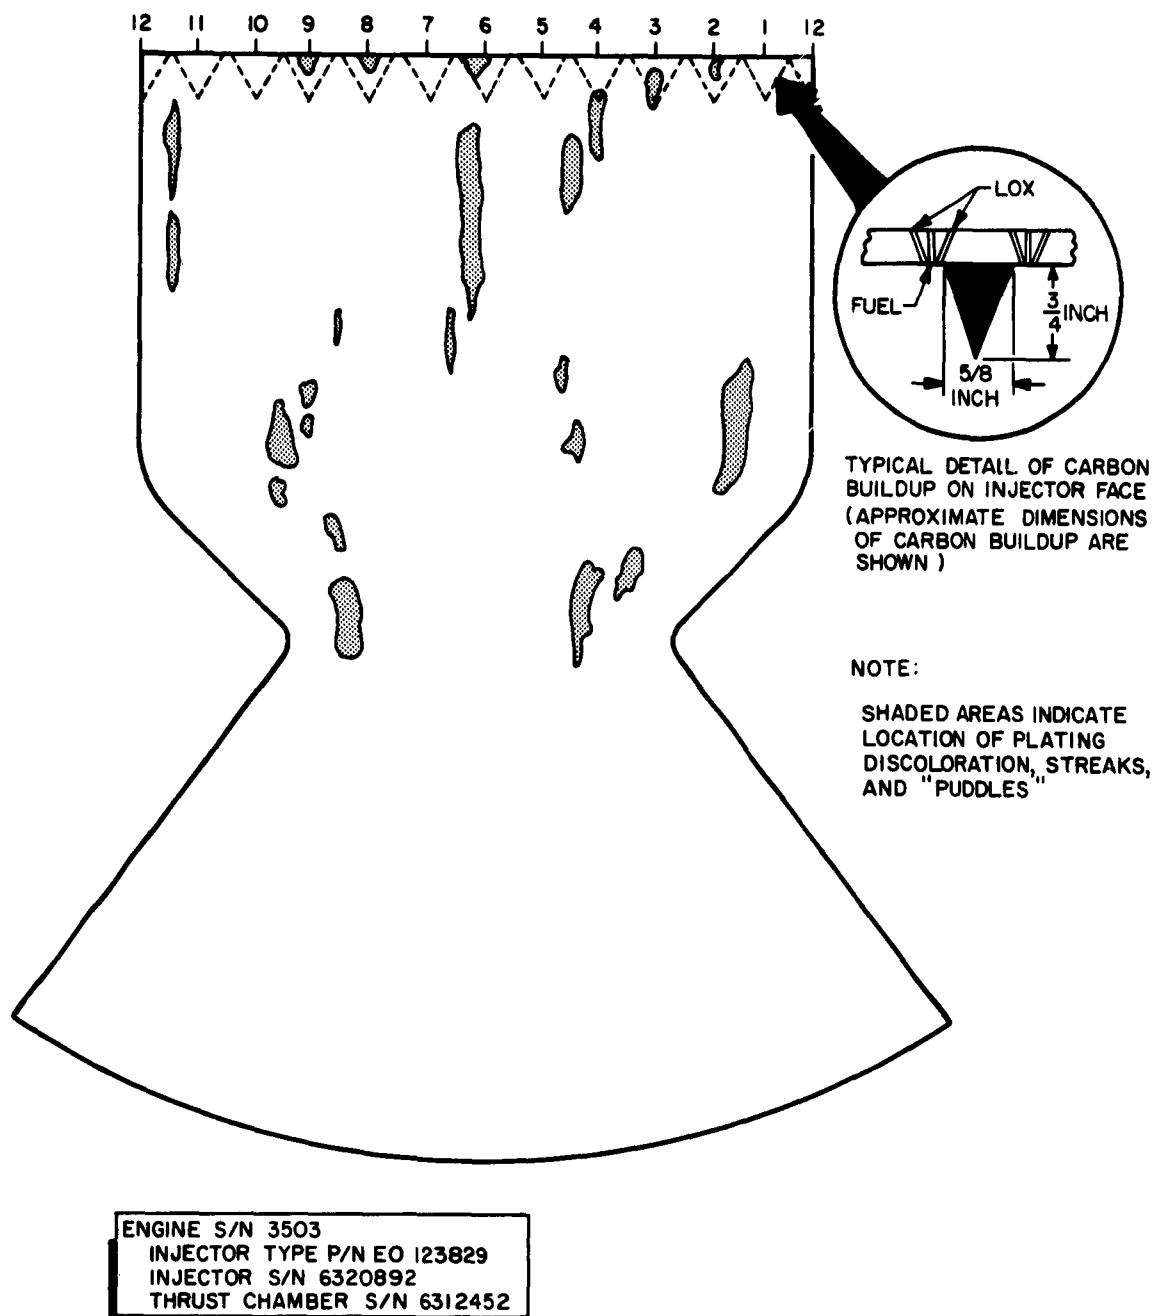
Although the wall of the first thrust chamber tested (engine S/N 3401) was only lightly coated with carbon, erosion was not detected until the thrust chamber was removed and cleaned. A subsequent test of the eroded area using an acid solution of copper sulphate showed that the erosion was into the parent metal. This solution turns exposed parent metal (type 4130 steel) to a copper color. As testing progressed, various means of detecting plating streaks and erosions were employed. These included wiping the carbon from the thrust chamber after every test, removing the injector periodically, and using the copper sulphate solution to check the spots that might be into the parent metal.

Figure 54. Typical Vernier Engine Thrust Chamber Inner Wall Following Testing
